INTEGRITY ASSESSMENT OF 3LPE COATED PIPES STORED IN OPEN ENVIRONMENT FOR SEVERAL YEARS

Abstract

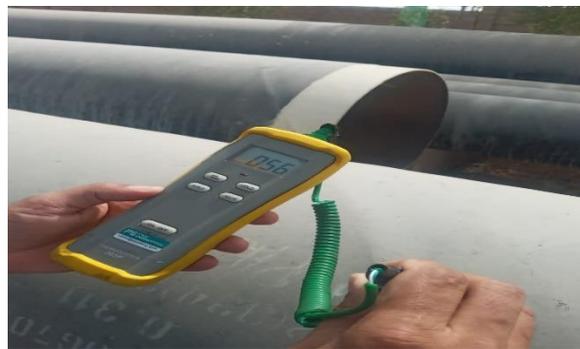
Fig. 2. Temperature of 3LPE coated pipe surface during summer season (Picture taken in May 2022)

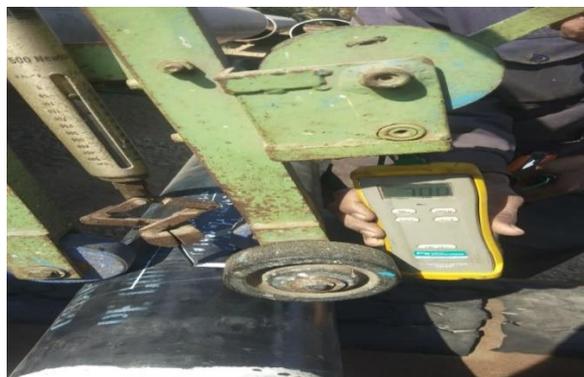
Fig. 3. Peel Adhesion test at higher temperature (Pipe temperature increased to 70 °C prior to peel test at 50 °C)

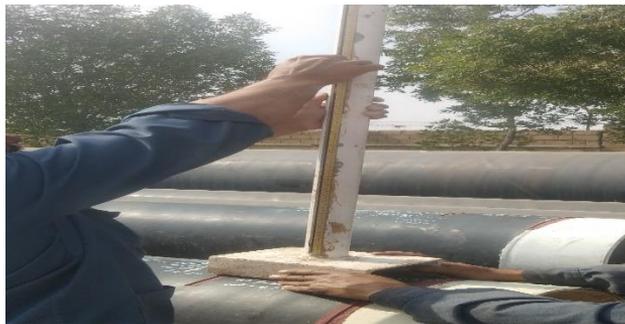
Fig. 3. Impact test at ambient temperature (25 +/- 3°C) with drop weight from certain height method

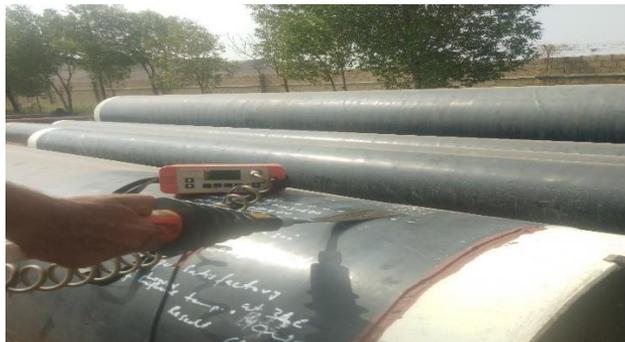
Fig. 4. Holiday detection at 25 KV after impact test

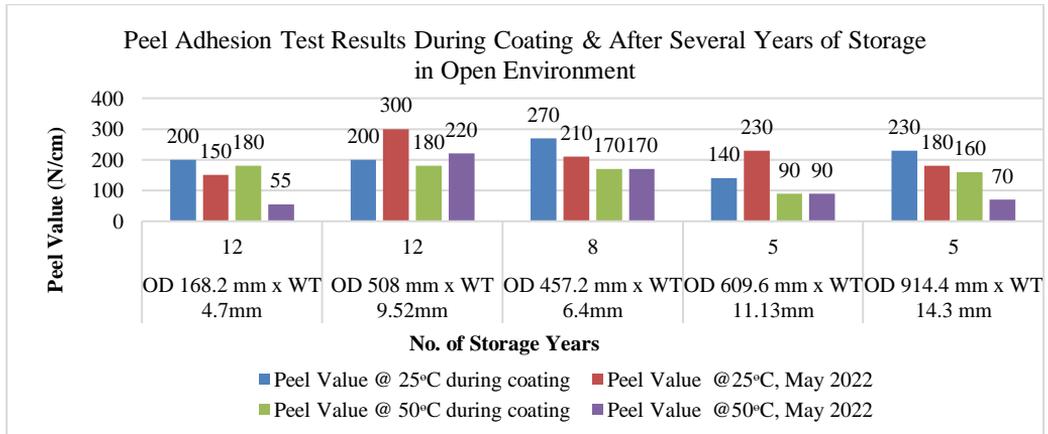
Fig. 5. Comparison of Peel adhesion test values during coating process and after several years of storage

Based on above results the top layer of 3LPE coating which is of HDPE was exposed to open environment (several years exposure to UV radiation of sun and temperature) however no significant degradation (except decrease of gloss of top layer i.e. HDPE material) in the mentioned properties of coating was due to some precautionary measures taken during long time storage which are:- Rotating the pipes in quadrants after every month so as to avoid long time sun exposure to particular area of pipe moreover corrosion protection on pipe ends in the form of epoxy based liquid paint was applied to avoid corrosion on bare ends of pipe (cut back portion). Further investigation for measuring the actual degradation of top layer (HDPE) in terms of percentage can be performed by first irradiating the HDPE sample (can be taken from 3 layer PE coating free from adhesive layer) with xenon lamp under specified conditions as per DIN 30670 [7] and ISO 4892-2 [8] and thereafter performing melt flow rate test.

Based on technical data sheets of top layer HDPE of different manufacturer, long time exposure in temperatures above 50°C and direct exposure of sun light to avoid UV rays is not recommended [9]. However, for large volume of pipes and on field storage where there is not feasible to provide storage of coated pipes in sheds it is critical to select the top layer HDPE with minimum 2 % carbon black content as UV absorber and to re-position pipes time to time to avoid long time exposure to single specific surface only.

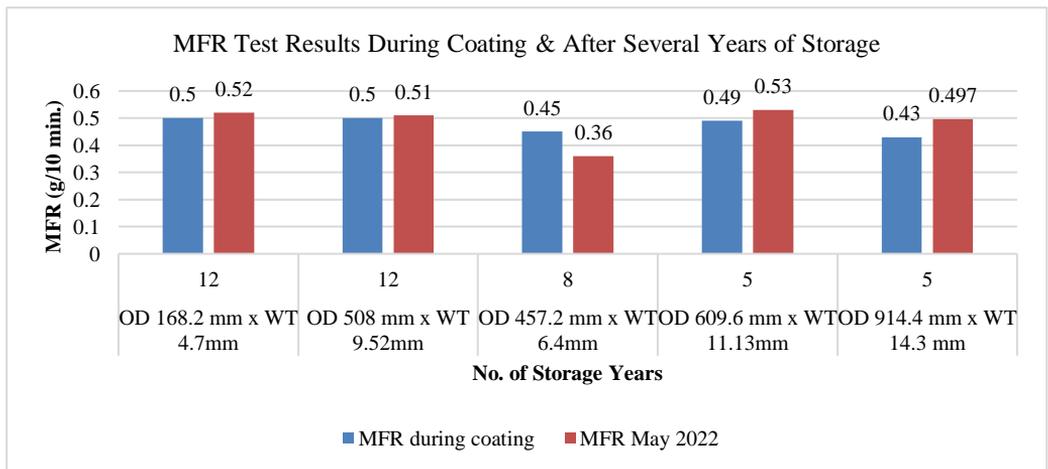
Fig. 6. Comparison of MFR test values during coating process and after several years of storage

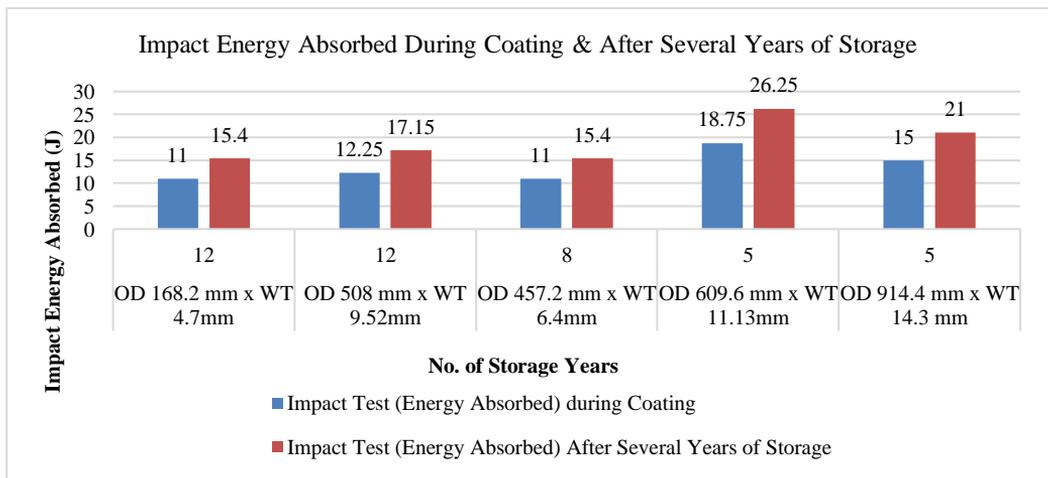
Fig. 7. Comparison of impact test values during coating process and after several years of storage
