INFLUENCE OF THE BONE CEMENTS AND CEMENTATION TECHNIQUE ON THE PERFORMANCE OF THE BIRMINGHAM HIP PROSTHESIS

Niculae VĂLEANU¹, Larisa POPESCU¹, Aurora ANTONIAC¹, Alina ROBU^{1,*},
Dan ANUSCA²

¹University POLITEHNICA of Bucharest, Faculty of Material Science and Engineering, Department of Materials Science and Physical Metallurgy, 313 Splaiul Independentei Street, 060042, Bucharest, Romania.

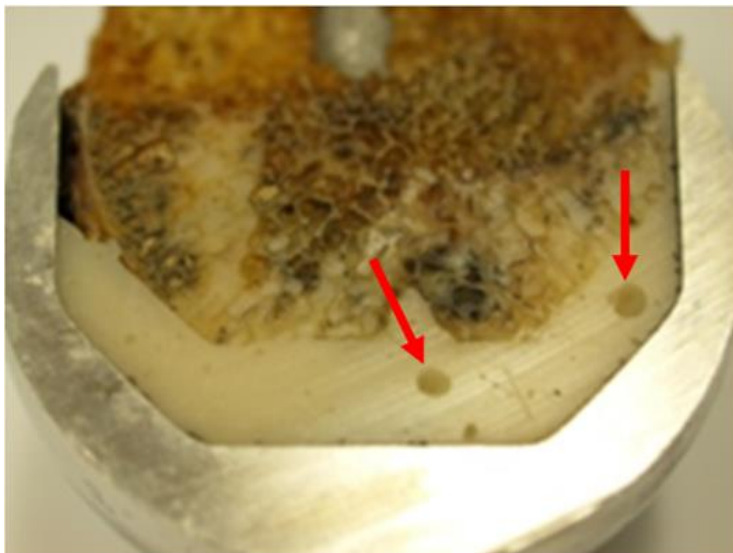
One of the major problems observed was the presence of air bubbles in the cement mantle. These air bubbles were caused by insufficient or inadequate mixing of the cement, which resulted in the formation of air voids that compromise the structural integrity of the cement.

These gaps prevented the cement from providing a firm and uniform fixation of the implant to the bone, contributing to the instability of the prosthesis.

Fig. 2. Air bubbles formed in the cement mantle

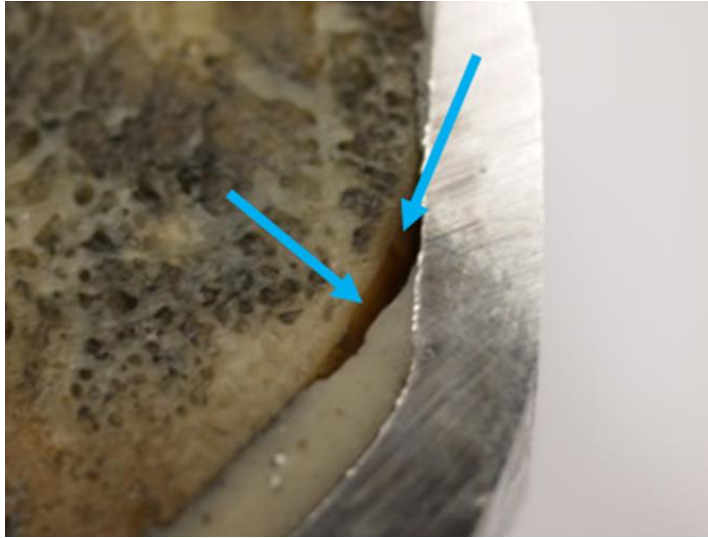
Another important irregularity was identified at the level of the interface between bone and cement (poor interface). This resulted from incomplete cleaning of the femoral canal before cement was applied, which allowed bone debris and other tissue materials to interfere with the bond between the cement and bone. The lack of optimal cement adhesion to the bone led to ineffective fixation and subsequent instability of the prosthesis.

Fig. 3. Cement irregularity at the bone-cement interface

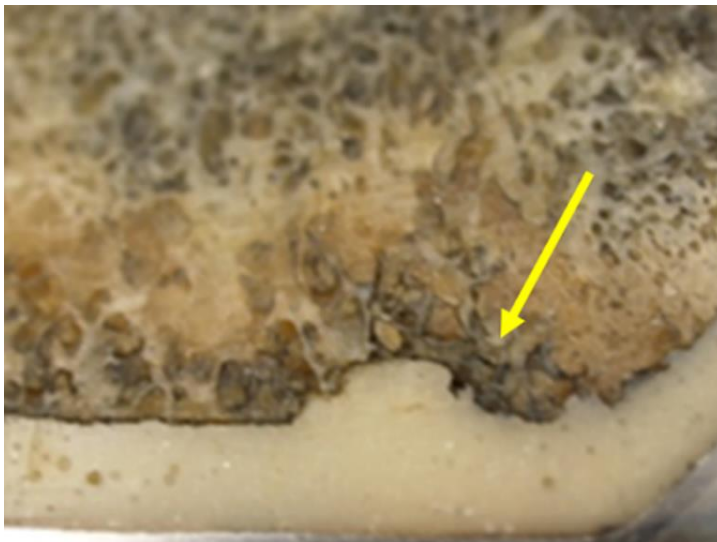
Also, the uneven thickness of the cement mantle (irregular mantle) was a critical factor. This was due to improper cement placement, either by using a cement that was too viscous and not evenly distributed, or by uneven application of pressure during cementing. An uneven cement mantle generated stress points and favoured micro-movements of the implant, which led to accelerated wear and failure of the prosthesis.

Fig. 4. Cement mantle with uneven thickness

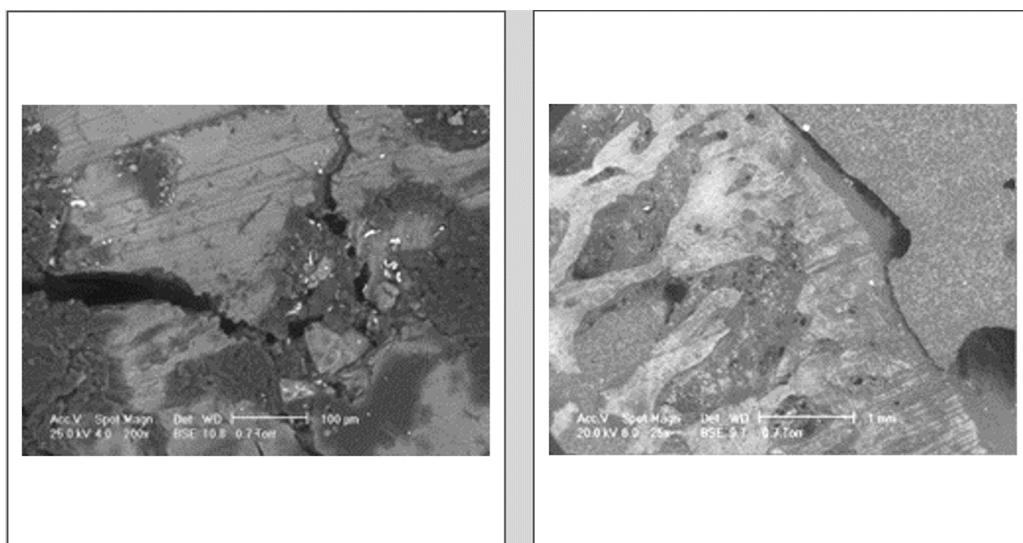
Scanning electron microscopy (SEM) allows the examination of explant surfaces at extremely high resolution, providing detailed images of the morphology of the bone-cement interface. Through SEM, the researchers were able to observe the presence of microcracks, porosity and air bubbles in the cement mantle, confirming that these structural defects contribute significantly to the instability of the implant. SEM also highlighted irregularities in cement distribution and identified areas of poor adhesion between bone and cement, which were associated with an increased risk of prosthesis failure.

Fig. 5. Highlighting structural irregularities of explants using scanning electron microscopy (SEM)

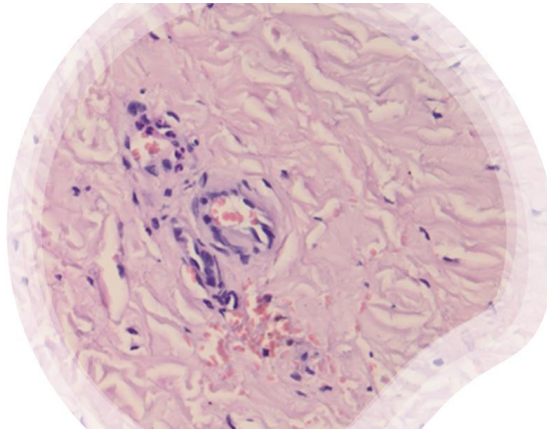
The histological analysis provided a complementary perspective, allowing the evaluation of biological interactions at the tissue-cement interface. By preparing and examining thin sections of non-decalcified processed bone tissue, the researchers were able to observe inflammatory responses, cell infiltration, and fibrous tissue formation around the cement. These observations revealed that, in many cases, the inadequate cementation technique resulted in poor biological integration, favouring the occurrence of adverse reactions such as desquamative proliferative synovitis and aseptic lesions associated with lymphocytic vasculitis (ALVAL). Histological analysis also showed that thermal osteonecrosis, caused by the heat generated during cement curing, contributed to the deterioration of the surrounding bone and reduced its ability to support the implant effectively.

Fig. 6. Evaluation of biological interactions at the level of the tissue-cement performed with the help of histological analysis

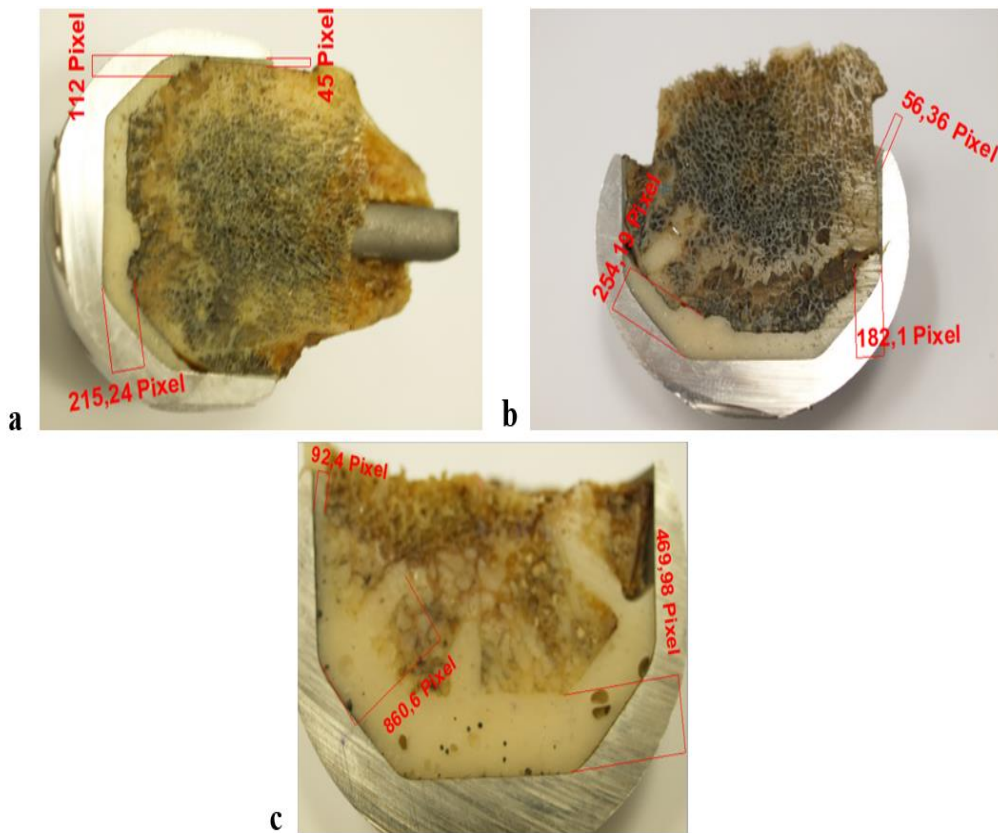
Fig. 9. Analysis of cement mantle thickness in the three zones of BHR implants

Our study highlighted significant variability in cement sheath thickness in failed BHR implants. In some cases, it was observed that the cement sheath was completely absent in zone 3, which led to the formation of irregularities and, ultimately, the failure of the prosthesis. These findings underscore the critical importance of proper cementation and cement layer uniformity to ensure the long-term success of BHR implants. Our macroscopic analysis showed that zone 1 consistently had the highest cement layer thickness, and in some cases, the cement exceeded the reference area, interacting directly with the bone. In contrast, zone 2, although generally within normal parameters, showed small inconsiderable deviations.

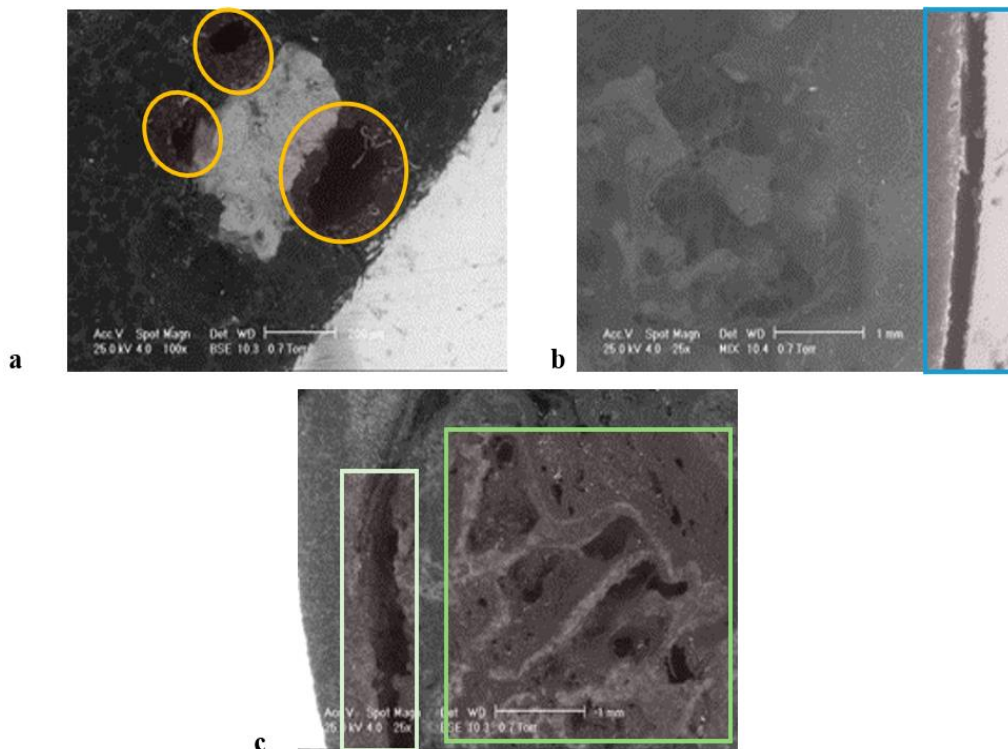
In the analysed samples, various defects were identified that led to the failure of BHR implants. In image 10 a, the mixing technique used for the preparation of acrylic cement was not efficient, highlighting the presence of air bubbles in the mass of the material. Also, the viscosity obtained did not have the necessary value for an efficient application, resulting in the same unevenness of the cement mantle, although the measurements indicate values close to the required standard size. In image 10 b, a coarse air gap is observed between the cement mantle and the bone, which prevents the formation of a proper cement-bone interface. Image 10 c also illustrates the lack of cement-bone interface, caused by improper cement application, and shows a much

more advanced bone necrosis state compared to previous cases; The cement penetrated the bone unevenly due to inadequate viscosity. The dark, porous-looking areas represent the necrotic bone, and the lighter areas around them indicate how the cement has penetrated the bone.

Fig. 10. SEM analysis of structural defects arising from the unfavourable cementing technique

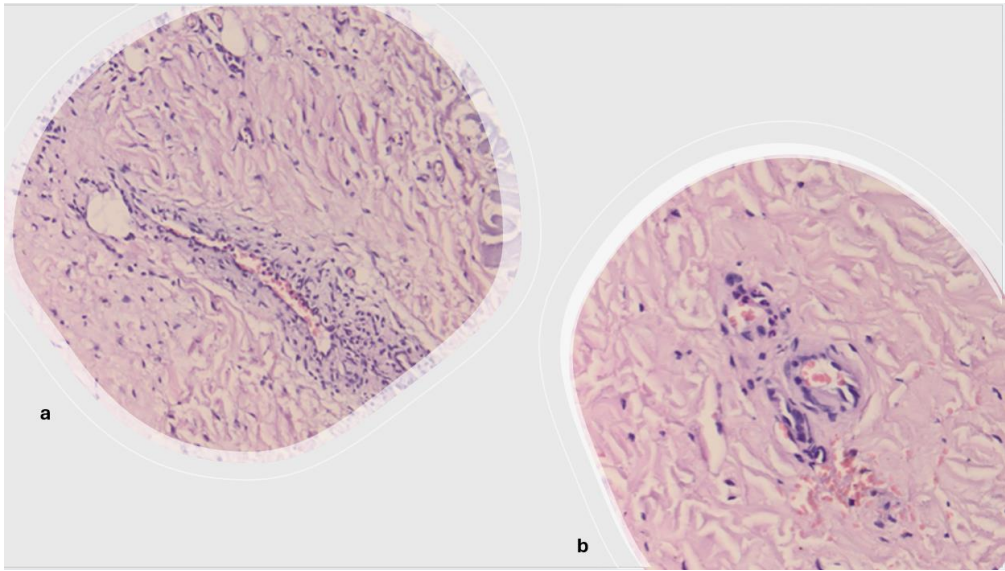
The interaction between the host tissue and the implanted material is particularly revealed in image 11 a, where rare perivascular inflammatory elements, predominantly lymphocytes, are highlighted. This histological appearance indicates a moderate inflammatory response around the cemented implant, in which lymphocytes, as elements of the immune system, are involved in the process of reaction to foreign material. This observation suggests that cementation had little impact on the surrounding tissue and may be associated with a relatively favourable integration of the implant into its biological environment.

Fig. 11. Histological analysis performed on tissue collected from the implant area
 a. perivascular inflammatory elements, with a predominance of lymphocytes (HE x200),
 b. minor interstitial blood extravasations and rare perivascular neutrophils (HE x400)).

Next, in image 11 b, small interstitial blood extravasations and rare perivascular neutrophils are noted. These findings indicate a mild inflammatory reaction, characterized by the limited presence of neutrophils, the cells responsible for phagocytosis and the elimination of pathogens, around the blood vessels. This inflammatory response may be associated with minimal trauma induced by the implantation and cementation process, suggesting a satisfactory tolerability of the materials used.
