INFLUENCE OF THE BONE CEMENTS AND CEMENTATION TECHNIQUE ON THE PERFORMANCE OF THE BIRMINGHAM HIP PROSTHESIS

Niculae VĂLEANU¹, Larisa POPESCU¹, Aurora ANTONIAC¹, Alina ROBU^{1,*},
Dan ANUSCA²

¹University POLITEHNICA of Bucharest, Faculty of Material Science and Engineering, Department of Materials Science and Physical Metallurgy, 313 Splaiul Independentei Street, 060042, Bucharest, Romania.

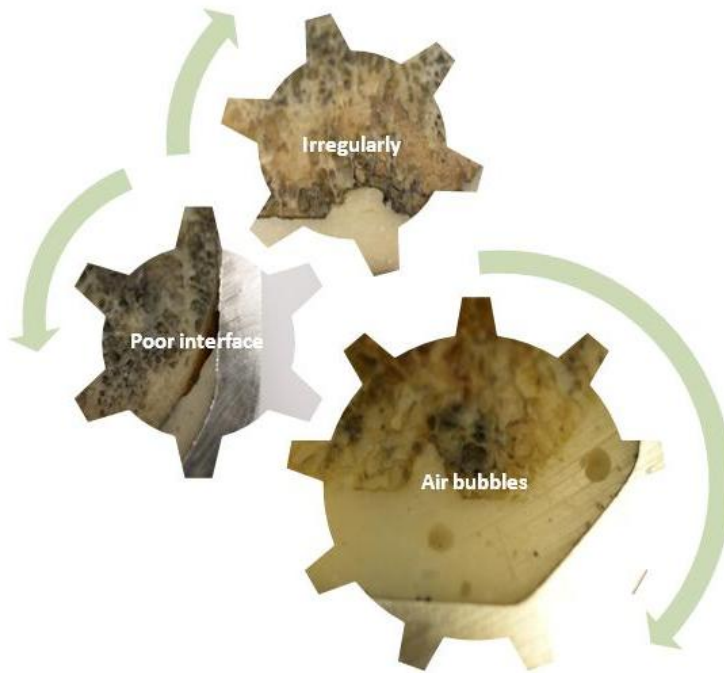
In a large study conducted at the Colentina Clinical Hospital in Bucharest, 300 Birmingham Hip Resurfacing (BHR) implantation surgeries were analysed. In this total, it was found that 10% of the implants failed, of which 10 cases were attributed to an unfavourable cementation technique. Detailed analysis of these cases revealed several critical irregularities that contributed to implant failure. From the macroscopic point of view, three major punctual defects were observed (Fig. 1).

Fig. 1. Diagram of irregularities arising from an inadequate cementing technique

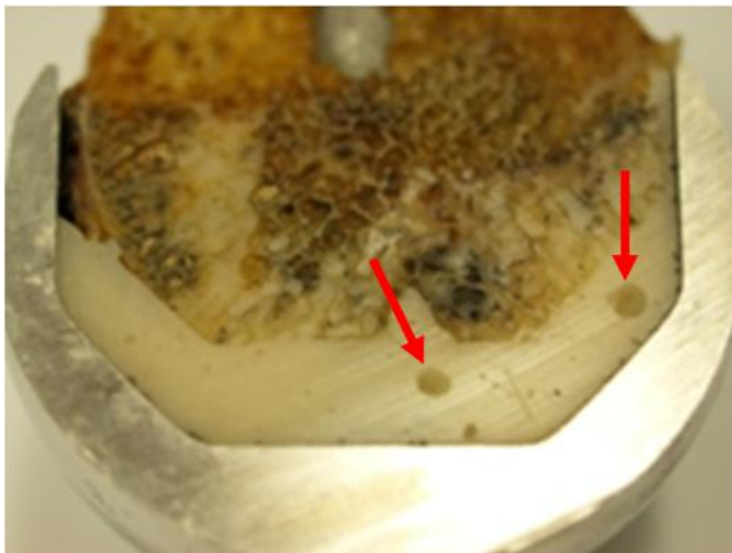
One of the major problems observed was the presence of air bubbles in the cement mantle. These air bubbles were caused by insufficient or inadequate mixing of the cement, which resulted in the formation of air voids that compromise the structural integrity of the cement (Fig. 2).

These gaps prevented the cement from providing a firm and uniform fixation of the implant to the bone, contributing to the instability of the prosthesis.

Fig. 2. Air bubbles formed in the cement mantle

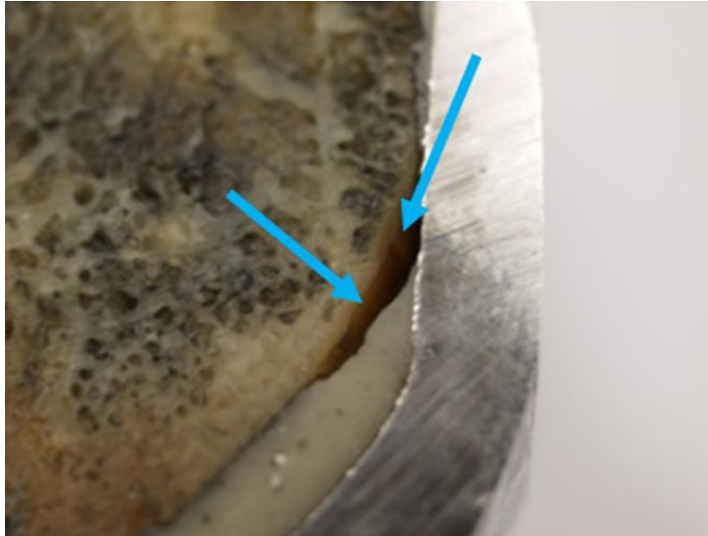
Another important irregularity was identified at the level of the interface between bone and cement (poor interface). This resulted from incomplete cleaning of the femoral canal before cement was applied, which allowed bone debris and other tissue materials to interfere with the bond between the cement and bone. The lack of optimal cement adhesion to the bone led to ineffective fixation and subsequent instability of the prosthesis (Fig. 3).

Fig. 3. Cement irregularity at the bone-cement interface

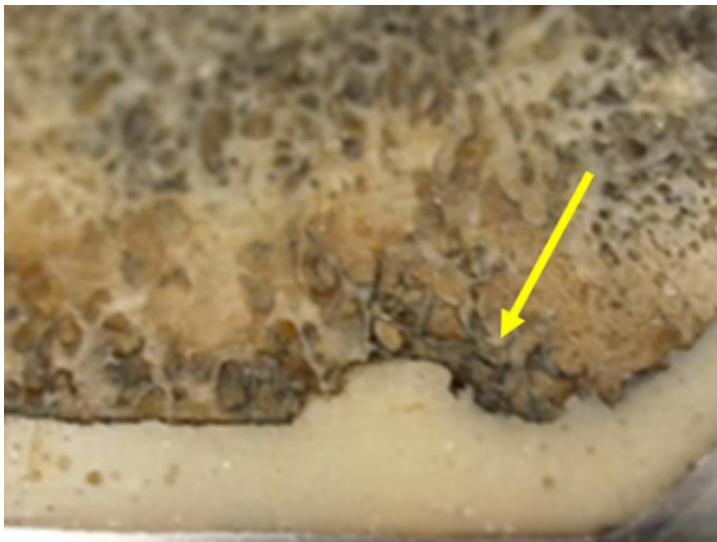
Also, the uneven thickness of the cement mantle (irregular mantle) was a critical factor. This was due to improper cement placement, either by using a cement that was too viscous and not evenly distributed, or by uneven application of pressure during cementing. An uneven cement mantle generated stress points and favoured micro-movements of the implant, which led to accelerated wear and failure of the prosthesis (Fig. 4).

Fig. 4. Cement mantle with uneven thickness

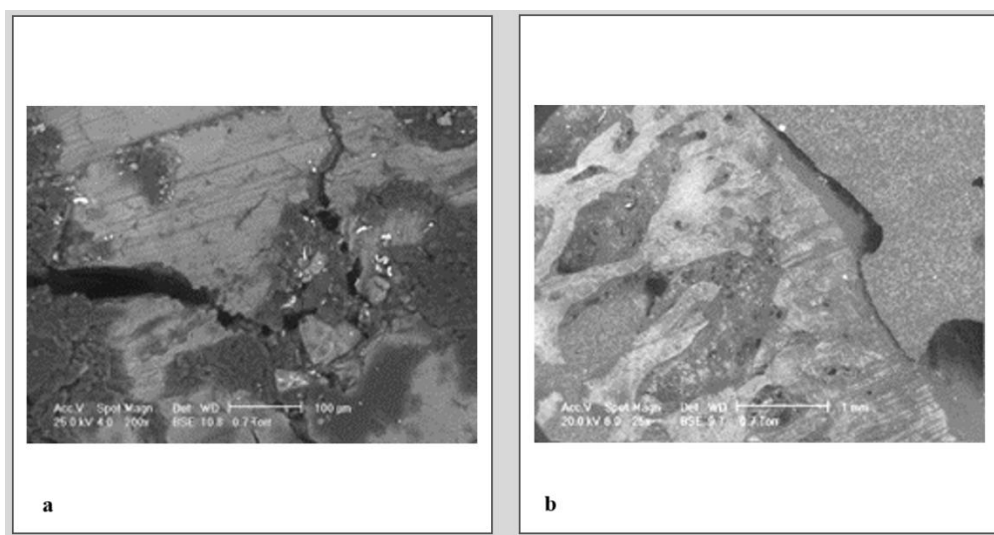
Scanning electron microscopy (SEM) allows the examination of explant surfaces at extremely high resolution, providing detailed images of the morphology of the bone-cement interface. Through SEM, the researchers were able to observe the presence of microcracks, porosity and air bubbles in the cement mantle, confirming that these structural defects contribute significantly to the instability of the implant. SEM also highlighted irregularities in cement distribution and identified areas of poor adhesion between bone and cement, which were associated with an increased risk of prosthesis failure. As shown in Fig. 5 a), SEM imaging reveals microcracks and porosity within the cement mantle. Fig. 5 b) highlights areas of poor adhesion and irregular cement distribution at the bone-cement interface, contributing to the likelihood of prosthesis failure.

Fig. 5. SEM Analysis of Bone-Cement Interface in BHR Prostheses: a) Microcracks, porosity, and air bubbles in the cement mantle observed at 700x magnification, which may contribute to implant instability; b) Poor adhesion areas between bone and cement, as well as irregular cement distribution observed at 250x magnification, associated with a higher risk of prosthesis failure)

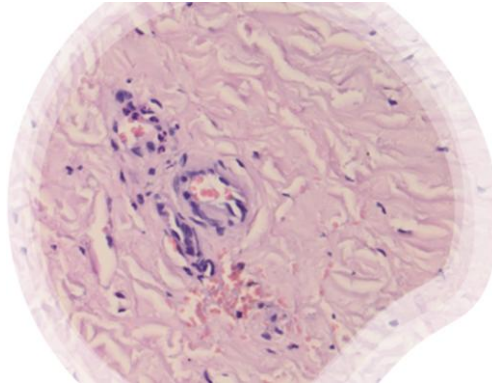
Fig. 6. Evaluation of biological interactions at the level of the tissue-cement performed with the help of histological analysis

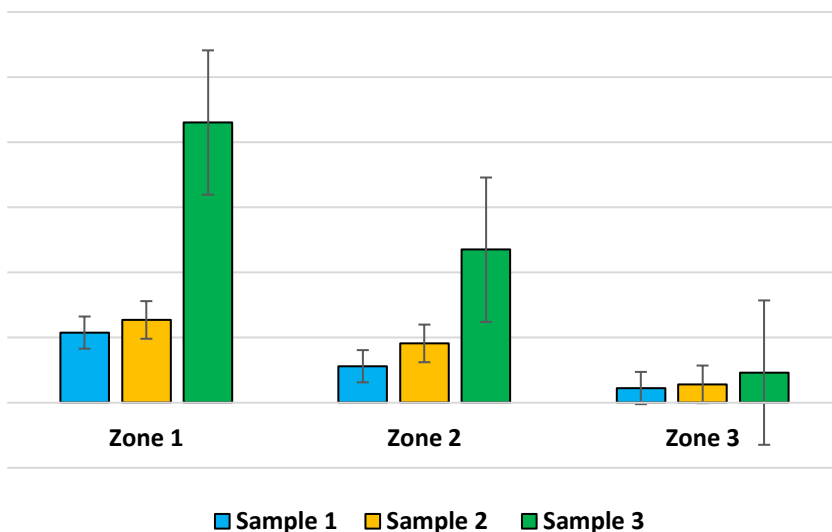
Fig. 8. Cement penetration in the different areas of BHR acetabular components

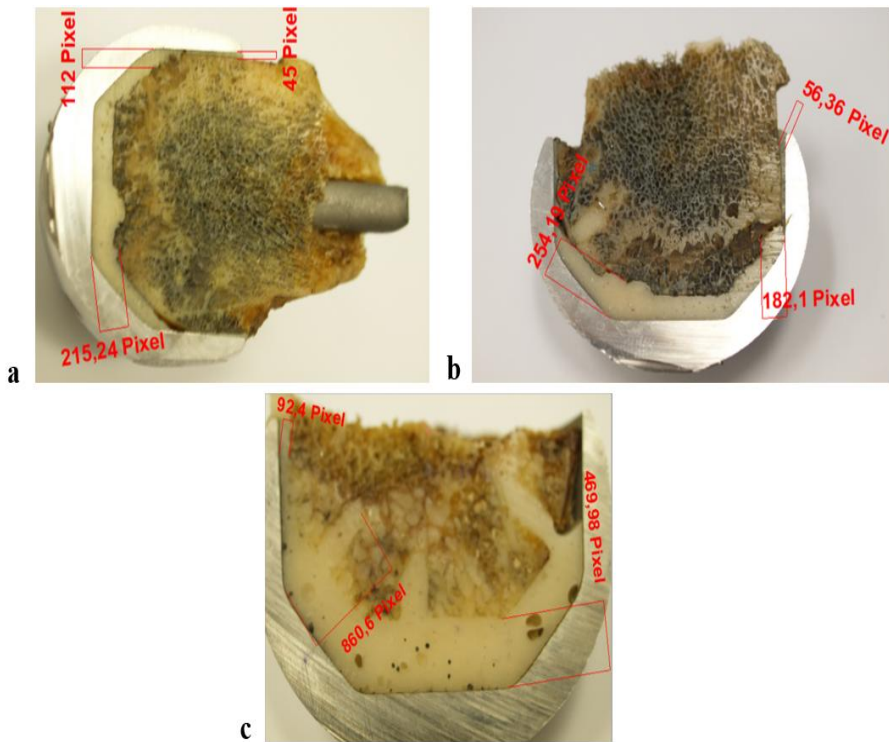
In our study, we analysed three explants of failed BHR prostheses, dividing the acetabular component into three zones (Fig. 9): the cap dome (zone 1), the intermediate zone (zone 2), and the radial zone (zone 3). Using macroscopic analysis and the AxioVision app, we measured the thickness of the cement layer in each area. Our analysis revealed the following:

Zone 1 and Zone 2: No substantial differences were identified in prosthetic designs and cement mantle thickness.

Zone 3: Exhibited a substantially smaller cement sheath. In some cases, irregularities have formed, with the cement mantle not completely covering this area.

Fig. 9. The analysis of the cement mantle thickness in three zones of the BHR implants:
a) zone 1; b) zone 2; c) zone 3

Our study highlighted significant variability in cement sheath thickness in failed BHR implants. In some cases, it was observed that the cement sheath was completely absent in zone 3, which led to the formation of irregularities and, ultimately, the failure of the prosthesis. These findings underscore the critical importance of proper cementation and cement layer uniformity to ensure the long-term success of BHR implants. Our macroscopic analysis showed that zone 1 consistently had the highest cement layer thickness, and in some cases, the cement exceeded the reference area, interacting directly with the bone. In contrast, zone 2, although generally within normal parameters, showed small inconsiderable deviations.

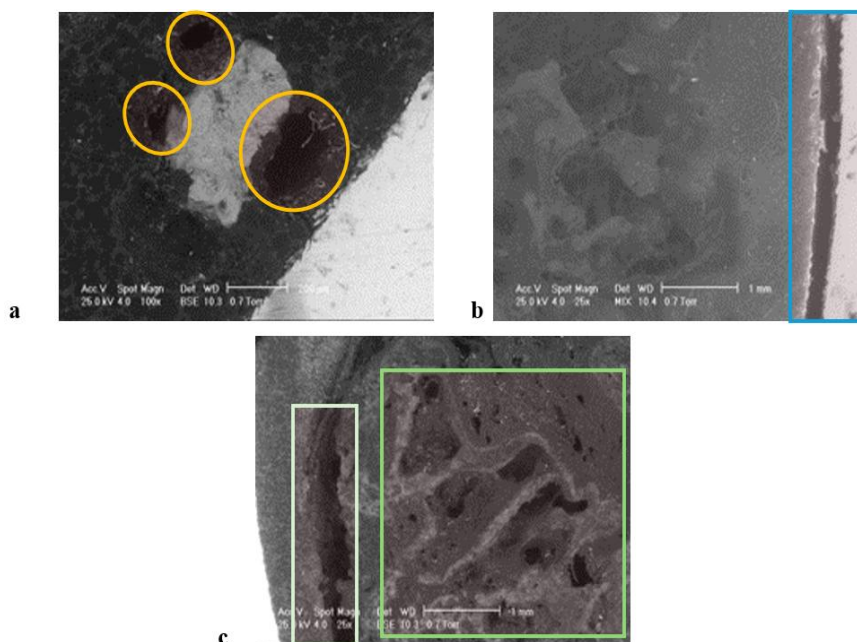
In the analysed samples, various defects were identified that led to the failure of BHR implants. In Fig. 10 a), the mixing technique used for the preparation of acrylic cement was not efficient, highlighting the presence of air bubbles in the mass of the material. Also, the viscosity obtained did not have the necessary value for an efficient application, resulting in the same unevenness of the cement mantle, although the measurements indicate values close to the required standard size. In Fig. 10 b), a coarse air gap is observed between the cement mantle and the bone, which prevents the formation of a proper cement-bone interface. Fig. 10 c) also illustrates the lack of cement-bone interface, caused by improper cement application, and shows a much more advanced bone necrosis state compared to previous cases; The cement penetrated the bone unevenly due to inadequate viscosity. The dark, porous-looking areas represent the necrotic bone, and the lighter areas around them indicate how the cement has penetrated the bone.

Fig. 10. SEM analysis of structural defects arising from the unfavorable cementing technique: a) Voids and porosity in the cement structure, circled in yellow, observed at 100x magnification, which may lead to mechanical instability; b) Delamination at the cement-bone interface, highlighted by the blue box, observed at 25x magnification, indicating poor adhesion; c) Microscopic surface irregularities within the cement mantle, highlighted by the green box, observed at 25x magnification, which can contribute to implant failure

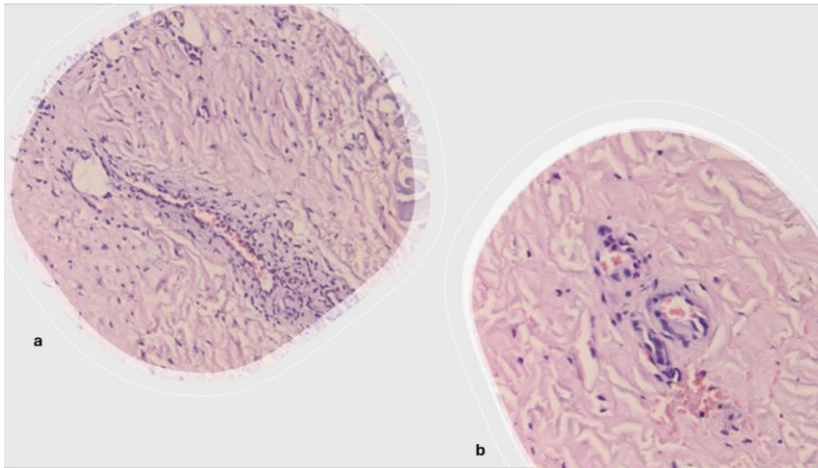
The interaction between the host tissue and the implanted material is particularly revealed in Fig. 11 a), where rare perivascular inflammatory elements, predominantly lymphocytes, are highlighted. This histological appearance indicates a moderate inflammatory response around the cemented implant, in which lymphocytes, as elements of the immune system, are involved in the process of reaction to foreign material. This observation suggests that cementation had little impact on the surrounding tissue and may be associated with a relatively favourable integration of the implant into its biological environment.

Fig. 11. Histological analysis performed on tissue collected from the implant area:
a) perivascular inflammatory elements, with a predominance of lymphocytes (HE x200);
b) minor interstitial blood extravasations and rare perivascular neutrophils (HE x400)

Next, in Fig. 11 b), small interstitial blood extravasations and rare perivascular neutrophils are noted. These findings indicate a mild inflammatory reaction, characterized by the limited presence of neutrophils, the cells responsible for phagocytosis and the elimination of pathogens, around the blood vessels. This inflammatory response may be associated with minimal trauma induced by the implantation and cementation process, suggesting a satisfactory tolerability of the materials used.
