FIELD VALIDATION OF ACOUSTIC LEAK DETECTION IN AN AGING URBAN WATER DISTRIBUTION SYSTEM: INFLUENCE OF AGING INFRASTRUCTURE ON ACOUSTIC LEAK DETECTION

Catrinel-Raluca GIURMA-HANDLEY¹[0009-0005-3518-078X], Alexandru POSTAVARU^{1*}[0009-0008-6733-1468], Ion GIURMA¹[0009-0009-5724-1984], Petru CERCEL¹[0009-0008-8924-9801]

¹ “Gheorghe Asachi” Technical University of Iasi, Faculty of Hydrotechnics, Geodesy and Environmental Engineering, Professor Ph.D Eng, Bd. D. Mangeron 65, Iași, 700050

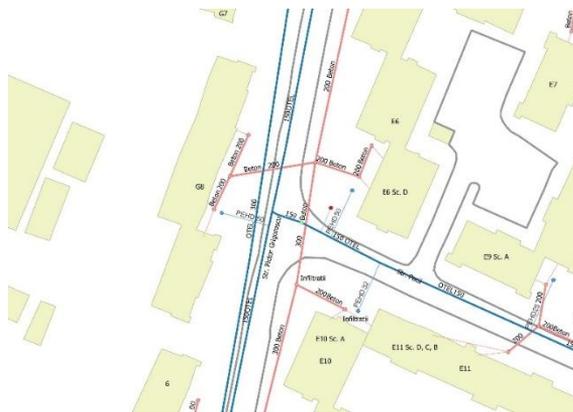
A relevant case involved the investigation of an infiltration issue in the vicinity of the E10 residential building, Staircase A, on Păcii Street in the city of Piatra Neamț (Fig. 1) – (*source: authors' own processing map, based on field investigations and network plans*). The infiltration manifestation was observed near the building's associated sewer manhole, while the nearest water supply main was located at approximately 6 m, consisting of an unprotected DN 150 mm steel pipe.

Fig. 1. Pipeline routes and intersections/nodes; points marked as “Infiltrations” (areas with potential infiltrations/network defects)

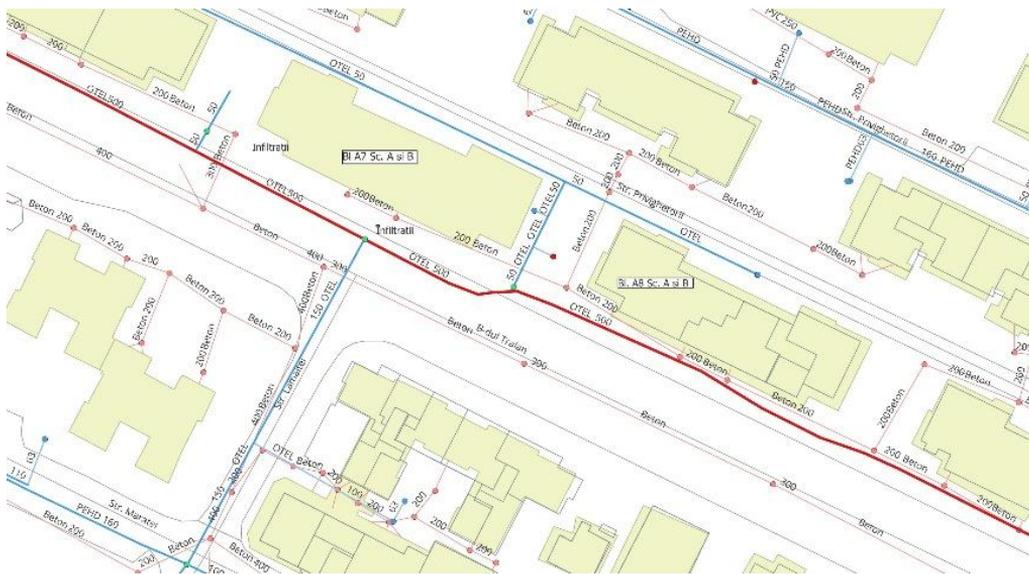
Another investigated case concerned the area on Traian Street, at the intersection with Lămâiței Street (Fig. 2) – (*source: authors' own processing map, based on field investigations and network plans*), following notifications submitted by the homeowners' associations of buildings A7 and A8 regarding indications of potable-water infiltration in the basements. The situation was assessed by applying acoustic leak detection methods in parallel with GPR investigations, using the equipment available within the NRW Unit [9], [10].

Fig. 2. Pipeline alignments and connection points (intersections/nodes), as well as the locations flagged as “Infiltrations,” representing areas with potential infiltrations or network defects

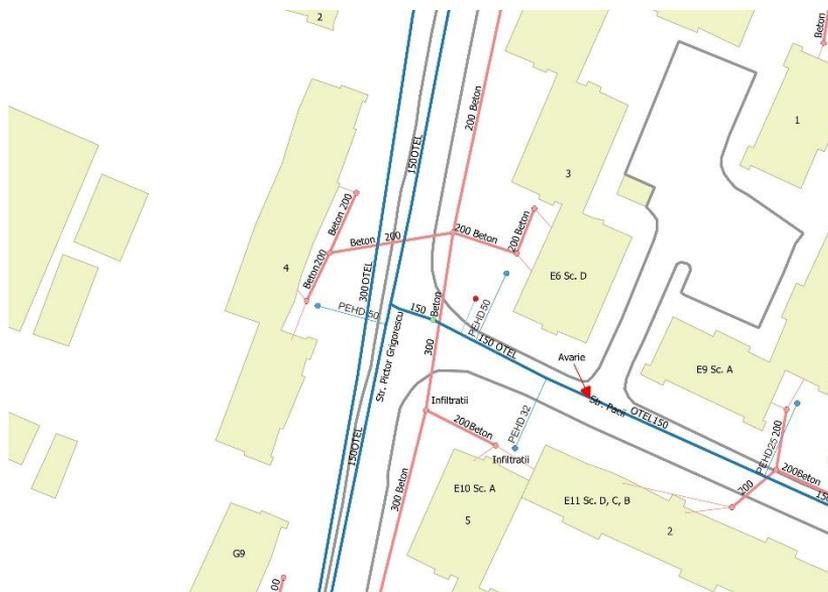
In the first case analyzed, related to Păcii Street, the use of the SebaKMT HydroLux HL7000 acoustic device (commonly referred to as an “electronic ear”) enabled delineation and identification of the sector with a high probability of failure, based on the noise level and the spectral signature associated with a pressurized leak (Fig. 3) – (*Source: authors’ own processing map, based on acoustic field investigations*).

Fig. 3. The estimated location of the “Failure/Leak,” marked with a red arrow on the section along Păcii Street

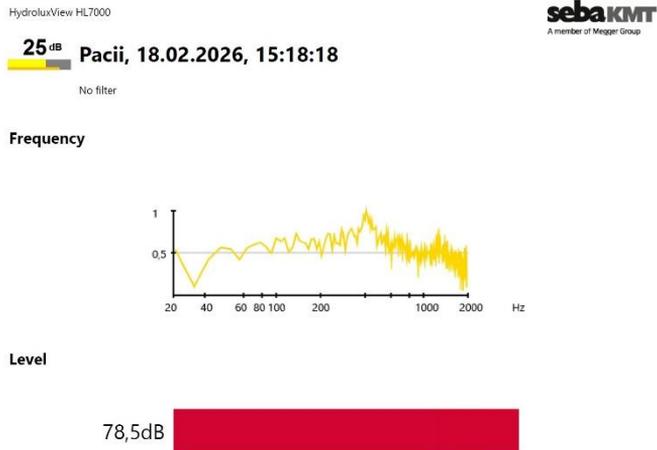
In the HydroLuxView HL7000 report without any filter applied (Fig. 4), the frequency spectrum reflects the energy distribution of the acoustic signal captured at the measurement point [8], including both components potentially associated with a leak and background noise originating from the network and the surrounding environment. The value “Level = 78.5 dB” represents the overall (integrated) level of the recorded signal rather than the amplitude at a single frequency, and its high magnitude suggests the presence of a relevant acoustic source nearby or an efficient transmission of vibrations to the sensing point. From an interpretive standpoint, this value is most useful when compared with measurements taken at successive points along the same section under similar conditions; using it as a universal “absolute” threshold for confirming a failure is less appropriate [6], [7], [8].

Fig. 4. Unfiltered acoustic detection graph

In the Păcii Street case, the unfiltered measurement indicated an overall acoustic level of 78.5 dB, whereas the application of the 160–800 Hz filter yielded 74.1 dB. Although the filtered value is slightly lower, the filtering stage improved the interpretability of the signal by isolating the frequency band most relevant for leak-related noise and by reducing parasitic low- and high-frequency components. This observation is consistent with the literature, which shows that leak identification is not determined only by signal amplitude, but also by the spectral quality of the signal and by the ability to distinguish leak-induced vibrations from background network noise, traffic, or operational disturbances [4], [6], [3]. Therefore, in this case, the main benefit of filtering was not simply noise reduction in a numerical sense, but the production of a cleaner and more stable acoustic signature for field interpretation.

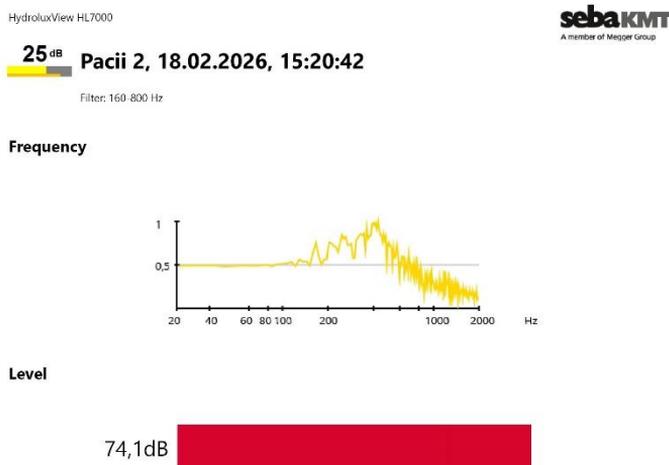
In the image in Fig. 5, the report with the 160–800 Hz filter applied enabled isolation of the frequency band [8] considered relevant for identifying the characteristic noise of leaks, reducing spurious contributions from low and high frequencies. The recording indicates an overall acoustic level of 74.1 dB, and the spectrum highlights energy concentrated predominantly in the mid-frequency range, suggesting a clearer, more stable acoustic signature for interpretation.

By restricting the spectrum to this band, the analysis becomes more robust and more comparable between successive measurement points, facilitating delineation of the section with a high probability of failure [6], [7], [8].

Fig. 5. Filtered acoustic detection graph

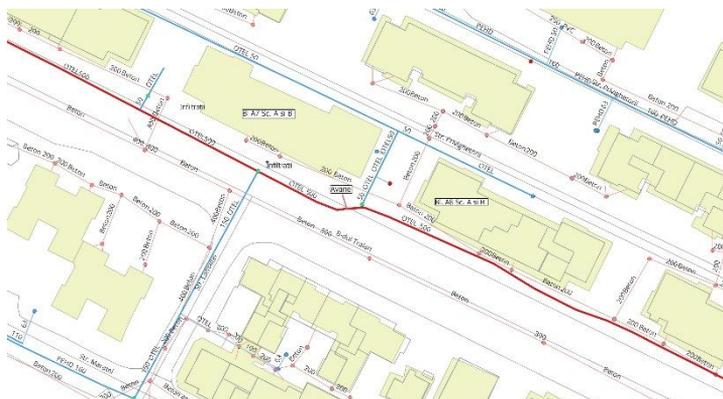
In the second investigated case, related to the Traian Street area—at the intersection with Lămâiței Street (Fig. 6) – (*Source: authors’ own processing map, based on acoustic field investigations*), detection equipment [8] enabled, following a campaign of measurements and successive verifications at representative points of the network, delineation of the sector with a high probability of failure. Analysis of noise levels and spectral signatures revealed consistent variations between the investigated points, indicating an acoustic source localized within the analyzed perimeter [1].

Fig. 6. Estimated location of the “Failure/Leak,” marked with a red arrow on the section along Traian Street

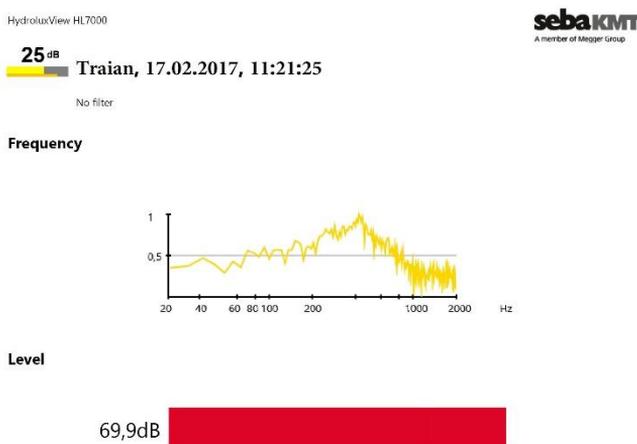
In the HydroLuxView HL7000 report for the “Traian” point in Fig. 7, acquired without any filter, the frequency plot [6], [8] shows the energy distribution of the acoustic signal across the entire analyzed range, including both components potentially associated with a leak and background noise. The value “Level = 69.9 dB” denotes the overall integrated signal level at the measurement point, indicating the presence of a perceptible acoustic source, but it does not separate parasitic contributions typical of low- or high-frequency regions. Consequently, the interpretation of this result is most meaningful when compared with measurements taken at

successive points along the same section, to observe variations in level and spectral signature [4], [5] as the survey approaches the suspected area [6], [7].

Fig. 7. Unfiltered acoustic detection graph on Traian Street

In the Traian Street case, the acoustic measurements showed an overall level of 69.9 dB without filtering and 67.0 dB with the 160–800 Hz filter. As in the previous case, the filtered result did not yield a stronger signal in absolute terms, but rather a more selective one, enabling better comparison between adjacent measurement points and a more reliable delineation of the sector with a high probability of failure. This is consistent with prior work indicating that acoustic leak detection in real networks is highly dependent on signal discrimination rather than on raw sound intensity alone, particularly in environments affected by background noise and mixed-frequency interference [4], [5], [6], [7].

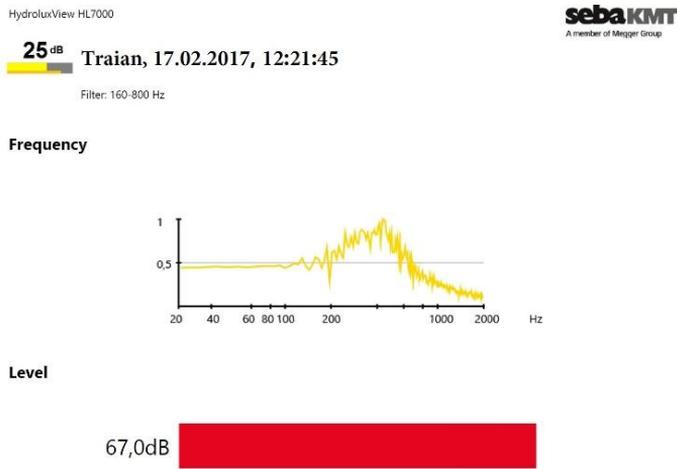
In the HydroLuxView HL7000 “Traian” report, with the 160–800 Hz filter applied [5] (Fig. 8), the frequency plot [6] captures only the spectral component relevant to leak-specific noise, largely removing parasitic influences at low and very high frequencies. The recorded overall level is “Level = 67.0 dB,” an integrated value across the filtered band, indicating a detectable acoustic signal within the “cleaner” interpretation range. The spectrum highlights an energy concentration [2], [3], [4], [5] in the mid-frequency region (with a peak around a few hundred Hz), which enables more robust comparison between successive measurement points and supports a more accurate delineation of the sector [1] with a high probability of failure [6], [7], [8].

Fig. 8. Filtered acoustic detection graph on Traian Street

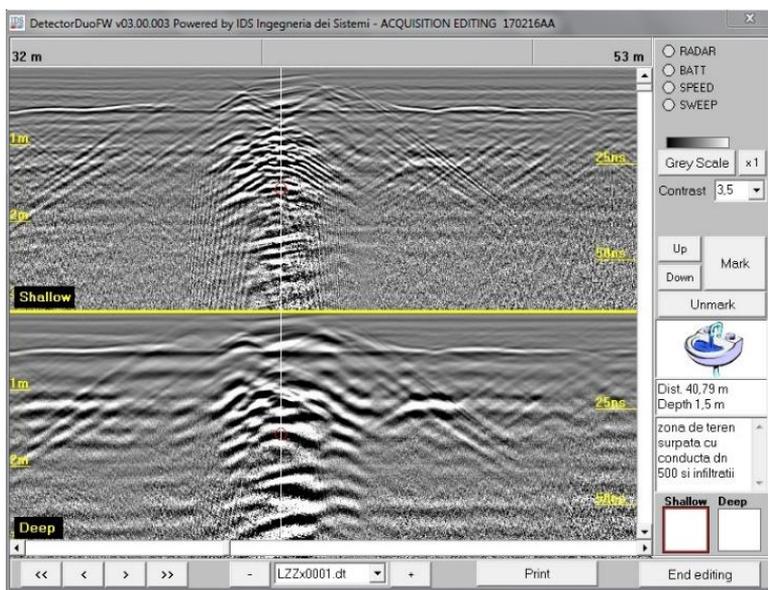
The image in Fig. 9 shows a radargram acquired with the DUO GPR on Traian Street, displayed in two processing windows: “Shallow” (for near-surface structures) [9] and “Deep” (for deeper zones) [9]. A well-defined “hyperbola” anomaly can be observed in the central area, characteristic of a buried linear object (typically a pipe) [3], [13], accompanied by disturbance of the surrounding stratification with infiltration zones, which may indicate changes in the medium (moisture/voids) [9], [10] associated with the infiltration phenomenon.

The indicator on the right shows a point marked at a distance of ~40.79 m along the profile and an estimated depth of ~1.5 m.

Fig. 9. Radargram on Traian Street

showing a significant anomaly at approximately 40.79 m along the profile and an estimated depth of about 1.5 m. The presence of a hyperbolic feature associated with disturbance of the surrounding stratification supports the interpretation that the investigated area was affected by moisture-related subsurface changes compatible with the reported infiltration phenomenon. This is in line with studies showing that GPR can improve leak investigation by identifying moisture anomalies, disturbed subsurface structure, and pipe-related responses that help reduce the excavation area and increase confidence before intrusive intervention [9], [10]. In our study, the combined use of acoustic detection and GPR did not replace direct verification, but significantly improved the pre-intervention diagnosis and targeting process.

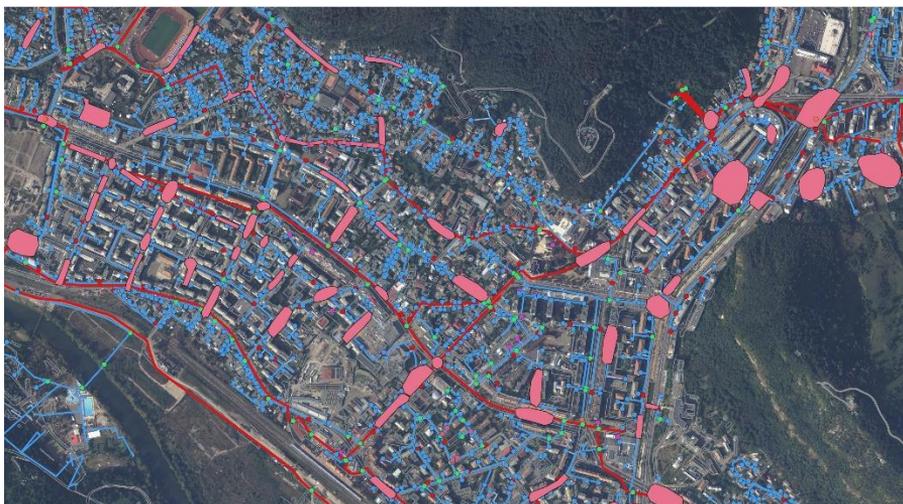
A broader operational perspective is provided by the thematic mapping of leak-prone sectors shown in Fig. 10 – (*Source: authentic map created in QGIS by the authors based on field investigations, acoustic surveys, GPR measurements, UAV flights, utility network records, and authors' own data processing*), which summarizes the areas identified through integrated field investigations using HydroLux HL 7000 acoustic listening equipment, ground penetrating radar (GPR), noise correlation systems, and UAV-based aerial inspections. This map highlights multiple failure-prone zones distributed across the metallic water distribution network, confirming that water losses in aging urban systems are rarely isolated events and are more often associated with broader patterns of infrastructure deterioration. In practical terms, the mapped sectors include both locations where failures have already been repaired and areas where the level of degradation, recurrence of failures, or diagnostic evidence justified the inclusion of pipe replacement works in the utility's investment plan.

Fig. 10. Map of the areas with failures identified in the metallic water distribution network through integrated investigations using HydroLux HL 7000 acoustic listening equipment, ground penetrating radar (GPR), noise correlation systems, and UAV survey flights
