FATIGUE AND TENSILE FRACTURE SURFACE MORPHOLOGIES OF ADDITIVE MANUFACTURED AUSTENITIC STAINLESS STEEL

Penn RAWN, Vadiraja SUDHAKAR*

Montana Technological University, Butte, MT 59701, USA

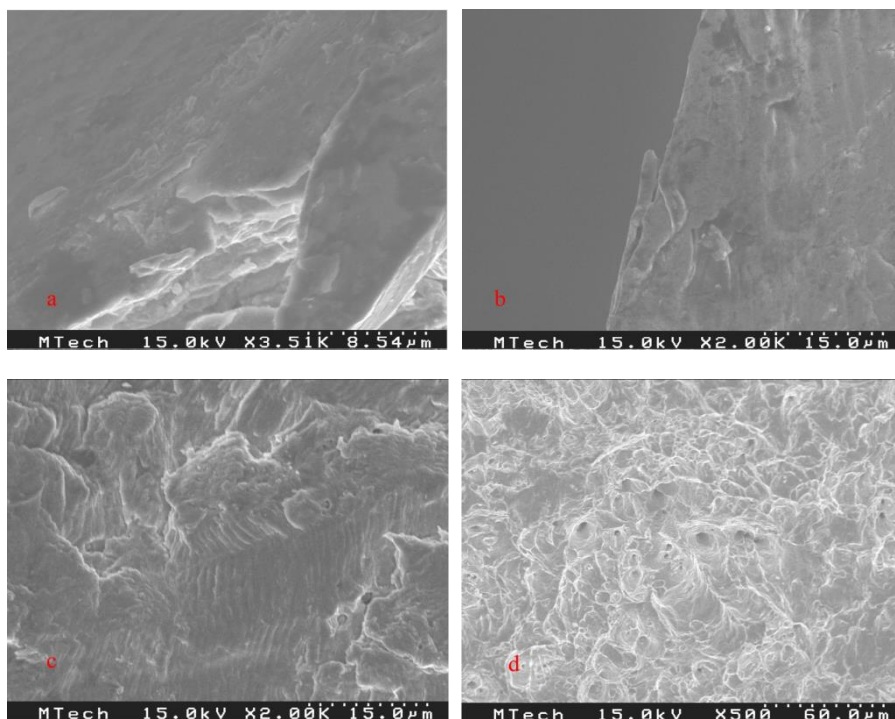
Figure 1a and 1b show the locations of crack initiation with the evidence of crack and folded material, respectively. The characteristic striation marks are evident in Figure 1c. The classical features of ductile fracture (voids, ductile ridges, dimples) are visible in Figure 1d.

Fig. 1. Fatigue fracture surface features of wrought specimens:
(a, b) for crack initiation, and (c), (d) for crack propagation and final fracture zones, respectively

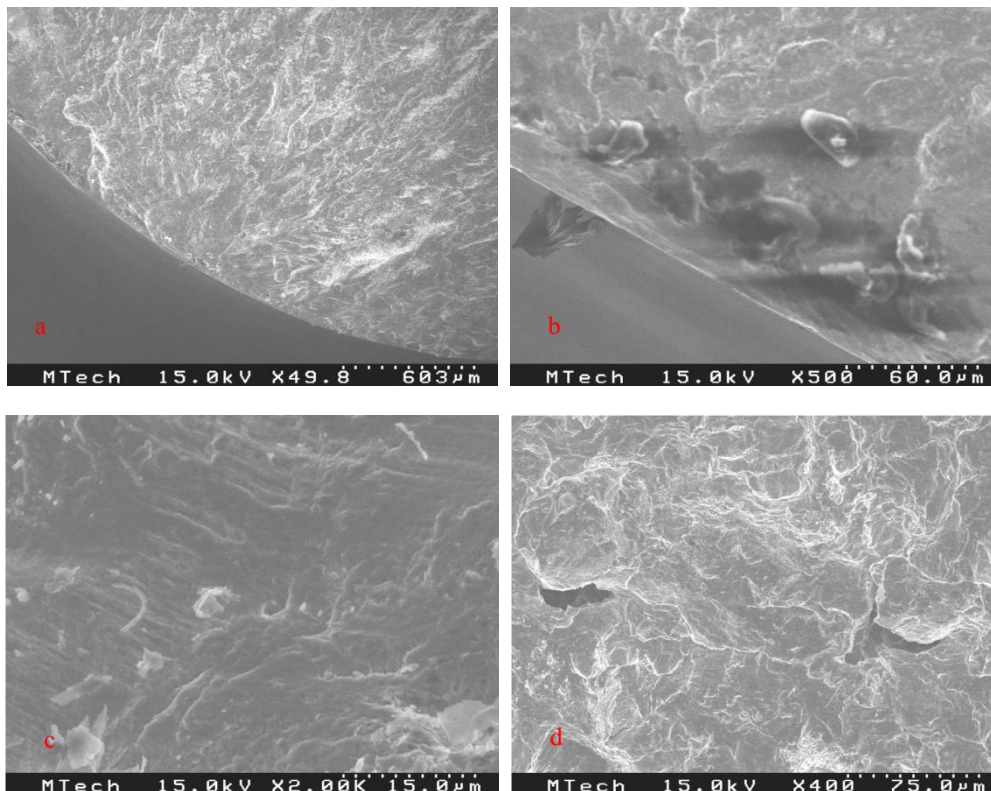
Figure 2 demonstrates the fatigue fracture surface features of specimens with 0° orientation. Crack initiation is shown in Figure 2a, and Figure 2b shows the same feature at a higher magnification revealing pores. Figure 2c and 2d show characteristic fatigue striations and faceted voids, respectively.

Fig. 2. Fatigue fracture surface features of 0° orientation specimens:
(a, b) for crack initiation, and (c), (d) for crack propagation and final fracture zones, respectively

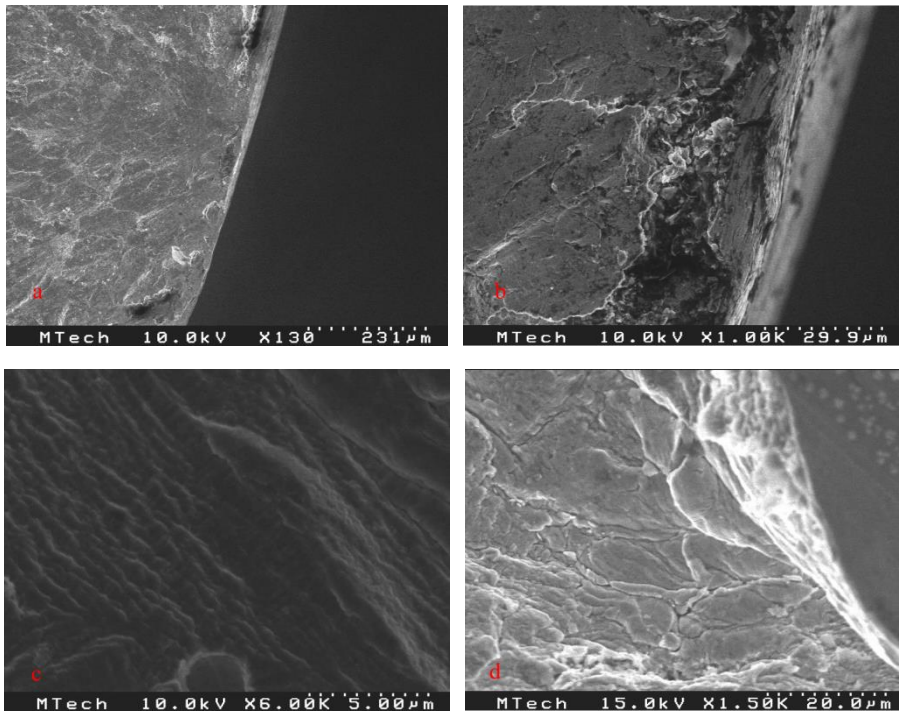
Crack initiation process is revealed in Figure 3a, as well as in Figure 3b, showing the presence of unmelted particles. The characteristic striation marks are visible in Figure 3c. Figure 3d depicts the region of final fracture with secondary cracks.

Fig. 3. Fatigue fracture surface features of 30° orientation specimens:
(a, b) for crack initiation, and (c), (d) for crack propagation and final fracture zones, respectively

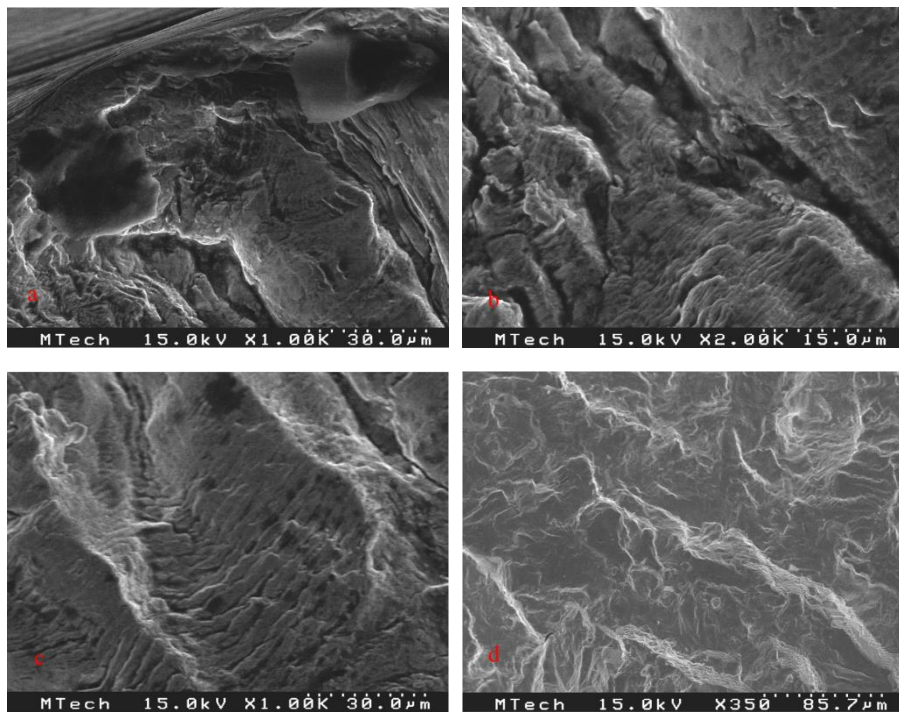
Figure 4a and 4b demonstrate crack initiation zone with voids. As demonstrated in the previous cases, striations are visible in Figure 4c and the final fracture surface features in Figure 4d.

Fig. 4. Fatigue fracture surface features of 60° orientation specimens:
(a, b) for crack initiation, and (c), (d) for crack propagation and final fracture zones, respectively

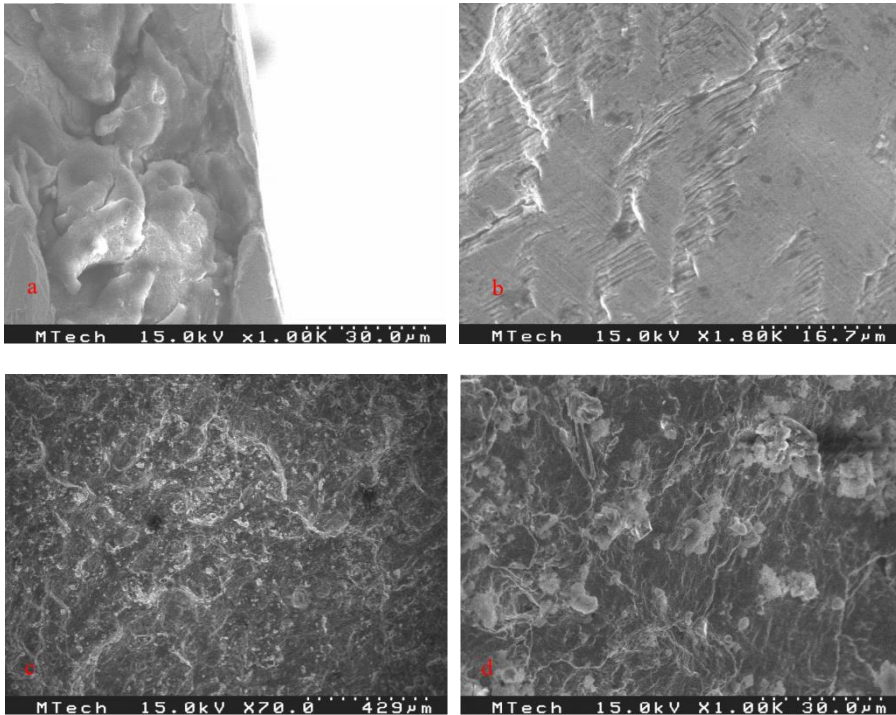
Figure 5a and 5b show voids that are responsible for the crack initiation process. Final fracture zone surface features are demonstrated in Figure 5c and 5d showing mostly ductile fracture features.

Fig. 5. Fatigue fracture surface features of 90° orientation specimens:
(a, b) for crack initiation, and (c), (d) for final fracture zones, respectively

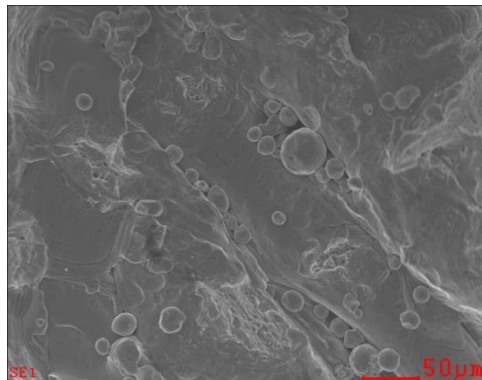
Fig. 6. Tensile fracture (energy density, 1.67 J/mm²) surface showing unmelted particles and partial fusion

Tensile fracture surface features of a tensile fractured specimen (90^0 build angle orientation) with a GED of 1.67 J/mm² are shown in Figure 6. Unmelted powder particles and interlayer delamination due to incomplete fusion are clearly visible. Ductile fracture features are visible in the areas of complete fusion.

The lowest energy density (1.67 J/mm^2) tensile specimens of 316L stainless steel demonstrated relatively more brittle fracture surface areas due to incomplete fusion of build layers during LPBF processing.

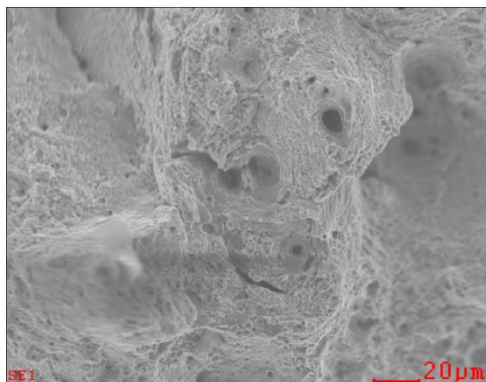
Stainless steel tensile specimen's fractured surface with a GED of 2.0 J/mm^2 (90^0 build angle orientation) is shown in Figure 7. A combination of ductile and brittle fracture features are visible in this fractograph. Fractured surface is characterized by the presence of a honey comb structure and relatively less ductile areas as indicated by relatively smoother/cleavage surfaces.

Fig. 7. Tensile fracture (energy density, 2.0 J/mm^2) surface showing honey comb structure and cleavage features at isolated locations

Mixed mode (ductile and brittle) fracture surface morphologies were observed for the 316L stainless steel tensile specimens produced with intermediate energy (2.0 J/mm^2) density.

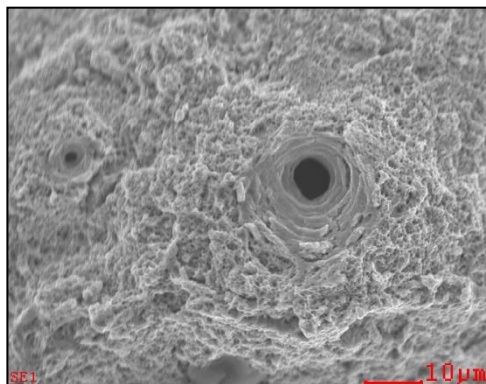
Fig. 8. Tensile fracture (energy density, 3.75 J/mm^2) surface revealing a highly ductile fracture features with voids

Figure 8 demonstrates the tensile fracture surface features of the specimen with a GED of 3.75 J/mm^3 (90^0 build angle orientation). Highly ductile failure, characterized by the presence of voids, fibrous features, is clearly visible.

The highest energy density (3.75 J/mm^2) tensile specimens exhibited predominantly a ductile fracture as a result of complete melting and fusion of layers.
