INFLUENCE OF THE BONE CEMENTS AND CEMENTATION TECHNIQUE ON THE PERFORMANCE OF THE BIRMINGHAM HIP PROSTHESIS

Niculae VĂLEANU¹, Larisa POPESCU¹, Aurora ANTONIAC¹, Alina ROBU^{1,*},
Dan ANUSCA²

¹University POLITEHNICA of Bucharest, Faculty of Material Science and Engineering, Department of Materials Science and Physical Metallurgy, 313 Splaiul Independentei Street, 060042, Bucharest, Romania.

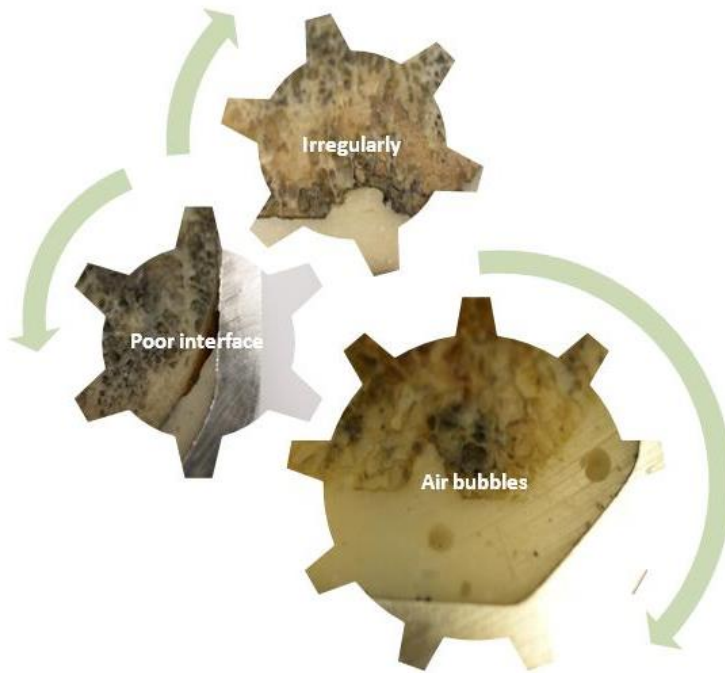
Fig. 1. Diagram of irregularities arising from an inadequate cementing technique

One of the major problems observed was the presence of air bubbles in the cement mantle. These air bubbles were caused by insufficient or inadequate mixing of the cement, which resulted in the formation of air voids that compromise the structural integrity of the cement.

These gaps prevented the cement from providing a firm and uniform fixation of the implant to the bone, contributing to the instability of the prosthesis.

Another important irregularity was identified at the level of the interface between bone and cement (poor interface). This resulted from incomplete cleaning of the femoral canal before cement was applied, which allowed bone debris and other tissue materials to interfere with the bond between the cement and bone. The lack of optimal cement adhesion to the bone led to ineffective fixation and subsequent instability of the prosthesis.

Also, the uneven thickness of the cement mantle (irregular mantle) was a critical factor. This was due to improper cement placement, either by using a cement that was too viscous and not evenly distributed, or by uneven application of pressure during cementing. An uneven cement mantle generated stress points and favoured micro-movements of the implant, which led to accelerated wear and failure of the prosthesis.

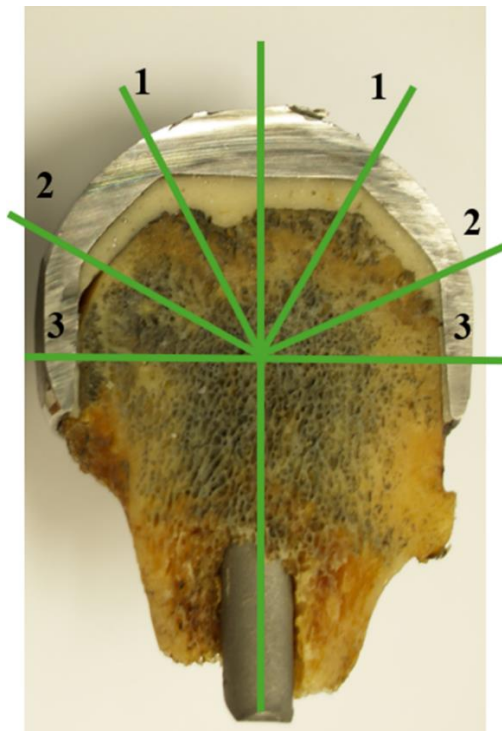
These precise measurements were made in three distinct areas of the implant: from the cap dome, referred to as zone 1, which is located at the top of the implant; from the intermediate zone, called zone 2, located in the middle of the implant shaft; and from the radial zone, called zone 3, located on the sides of the implant rod. This detailed method of measuring the cement thickness on each side of the implant shaft allowed for a comprehensive assessment of the distribution and uniformity of the cement mantle, thus ensuring a better understanding of the factors influencing the long-term stability and success of the prostheses.

Fig. 7. Systematic schematic representation of cement thickness measurements (1 - lid zone, 2 - intermediate zone, 3 - radial zone)

Zone 1 and Zone 2: No substantial differences were identified in prosthetic designs and cement mantle thickness.
