INFLUENCE OF THE BONE CEMENTS AND CEMENTATION TECHNIQUE ON THE PERFORMANCE OF THE BIRMINGHAM HIP PROSTHESIS

Niculae VĂLEANU¹, Larisa POPESCU¹, Aurora ANTONIAC¹, Alina ROBU^{1,*},
Dan ANUSCA²

¹University POLITEHNICA of Bucharest, Faculty of Material Science and Engineering, Department of Materials Science and Physical Metallurgy, 313 Splaiul Independentei Street, 060042, Bucharest, Romania.

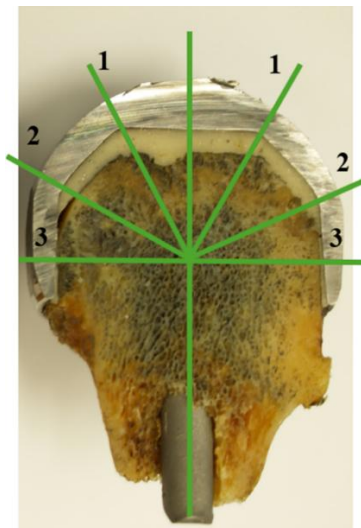
These precise measurements were made in three distinct areas of the implant: from the cap dome, referred to as zone 1, which is located at the top of the implant; from the intermediate zone, called zone 2, located in the middle of the implant shaft; and from the radial zone, called zone 3, located on the sides of the implant rod (Fig. 7). This detailed method of measuring the cement thickness on each side of the implant shaft allowed for a comprehensive assessment of the distribution and uniformity of the cement mantle, thus ensuring a better understanding of the factors influencing the long-term stability and success of the prostheses (Fig. 8).

Fig. 7. Systematic schematic representation of cement thickness measurements
(1 - lid zone, 2 - intermediate zone, 3 - radial zone)
